Crack Healing of High Temperature Hydrogen Attack Corrosion by Heat Treatment

Azzura Ismail, Azlizul Aizat Razali, Asliaty Atim, Muhammad Amin Ali, Hariti Hasan

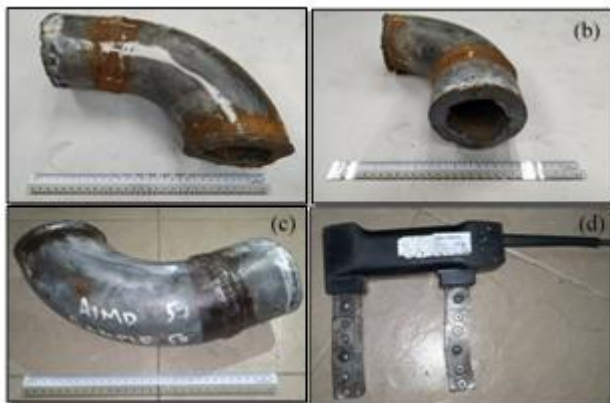
Fig 1. Failed pipe preparation for MPI

Visual identified cracks presence on circumference (concave surface) inner surface of the carbon steel caused by the hydrogen attack. Fig 1(a) showed the carbon steel pipe that already undergoes failure due to hydrogen attack which has been cut by oxy-acetylene torch cutting and wire-cut EDM cutting on the welding area (high-stress area).

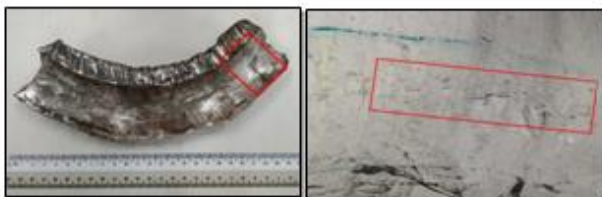
Fig 2. Crack finding in curvature area

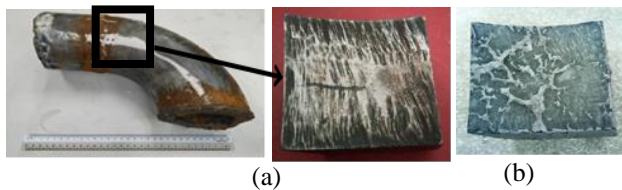
Heat treatment was done on the specimen to observe the reduction of crack length after undergoing heat treatment. It was annealed to 850°C with a holding time of two hours. The crack length of the specimen is reduced to 9 mm from 13mm after undergoing heat treatment with a total crack reduction of 30.77% as shown in Fig 3 while Table 2 listed the crack reduction. Visual inspection also identified of oxide layer during heat treatment was fragile and can easily scrapped off.

Fig 3: Crack on the surface of carbon steel (a) before and (b) after heat treatment

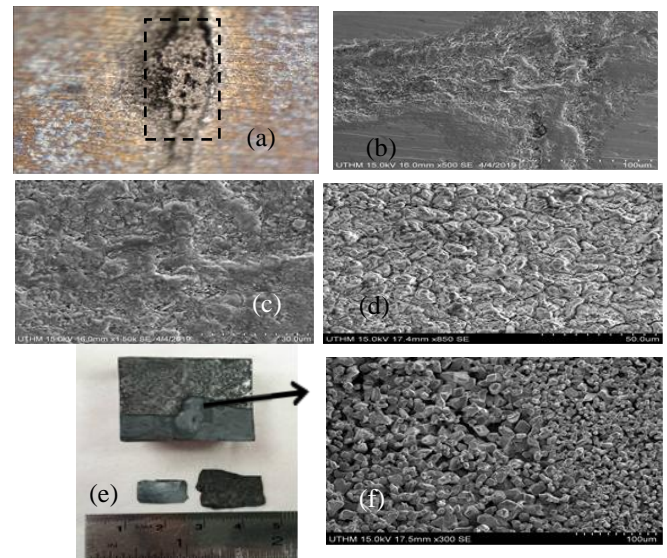
By observing the crack under the optical microscope, the images of the crack were obtained. The crack on the carbon steel specimen was caused by the formation of methane gas (CH_4), results from reaction of hydrogen with carbon in the steel. As the temperature and pressure were high, the methane gas did not escape and causing cracks on the wall of the carbon steel pipe (High Temperature Hydrogen Attack). Hence, Fig 4 below showed the crack that was contributed by the methane gas. The crack image that was observed under an optical microscope is 10x magnification.

Fig 4: Crack on carbon steel at different magnification and oxide layers (right bottom).

SEM result on the metallography was done before the specimen which is the carbon steel undergo heat treatment and also after undergoing heat treatment. Fig 4 (e) and (f) show the crack surface image observed by SEM showing intergranular cracks of corrosion. Moreover, decarburization occurs where carbon steel loses the amount of carbon. It can be seen in Fig 4(b). The difference between the crack area and the not affected area showed that decarburization has occurred to the carbon steel that has been subjected to HTHA. The microstructure also was identified after the heat treatment. It was revealed that the surface was fully covered by oxide layer after the heat treatment. Fig 4 (e) and (f) how the base metal after heat treatment without oxide layer attached. The surface denser with porous granulations showing some carbon missing during hydrogen attack. The white granules seem to appear in numbers on the surface without an oxide layer. The oxide layer easily peeled off showing that a fragile and crystalline like structure (Fig. 4 (f)) was formed during heat treatment.

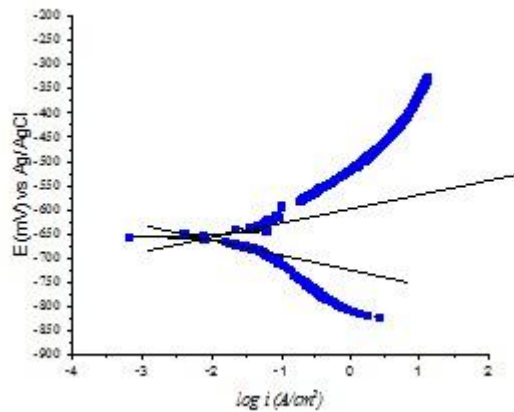
The electrochemical was run for Tafel scan to identified current density after the sample had gone through heat treatment. The scan rate used is 2mV/sec where the area of the specimen is 8 cm². The value of corrosion current density (I_{corr}), corrosion potential (E_{corr}), open circuit potential (OCP) and corrosion rate (CR) can be obtained. Tafel plot as shown in Fig 3 gives the values 17.974 μA , -656.783 mV and - 656.9 mV for I_{corr} , E_{corr} , OCP respectively.

The corrosion rate was then calculated and given to value 26.081 mm/year. Quite a high rate due to oxidation reaction to give oxide layer for protection purposes. This gives a sign that the corrosion rate characterised the value of oxidation rate to formed oxide layer on carbon steel.

Fig. 5: Electrochemical by Tafel scan to identify current density and other corrosion properties
