Deterioration of a Building through Environmental and Anthropological Causes

Kirti Chandra D., D. V. K. Sudhakar

A residential house in Sagar Nagar, Visakhapatnam [7], has been identified for the case study. The house is a perfect example of the condition that will be witnessed when maintenance is not done regularly for a building by the occupants. A duplex house, with greater percentage of open spaces in the site, was originally intended to be used as a weekend farm house. Over the years, the building has become prone to various factors leading to its current state. Hence, a study of its current condition would give us results that would be helpful in understanding the problems caused when the maintenance strategies are not followed.

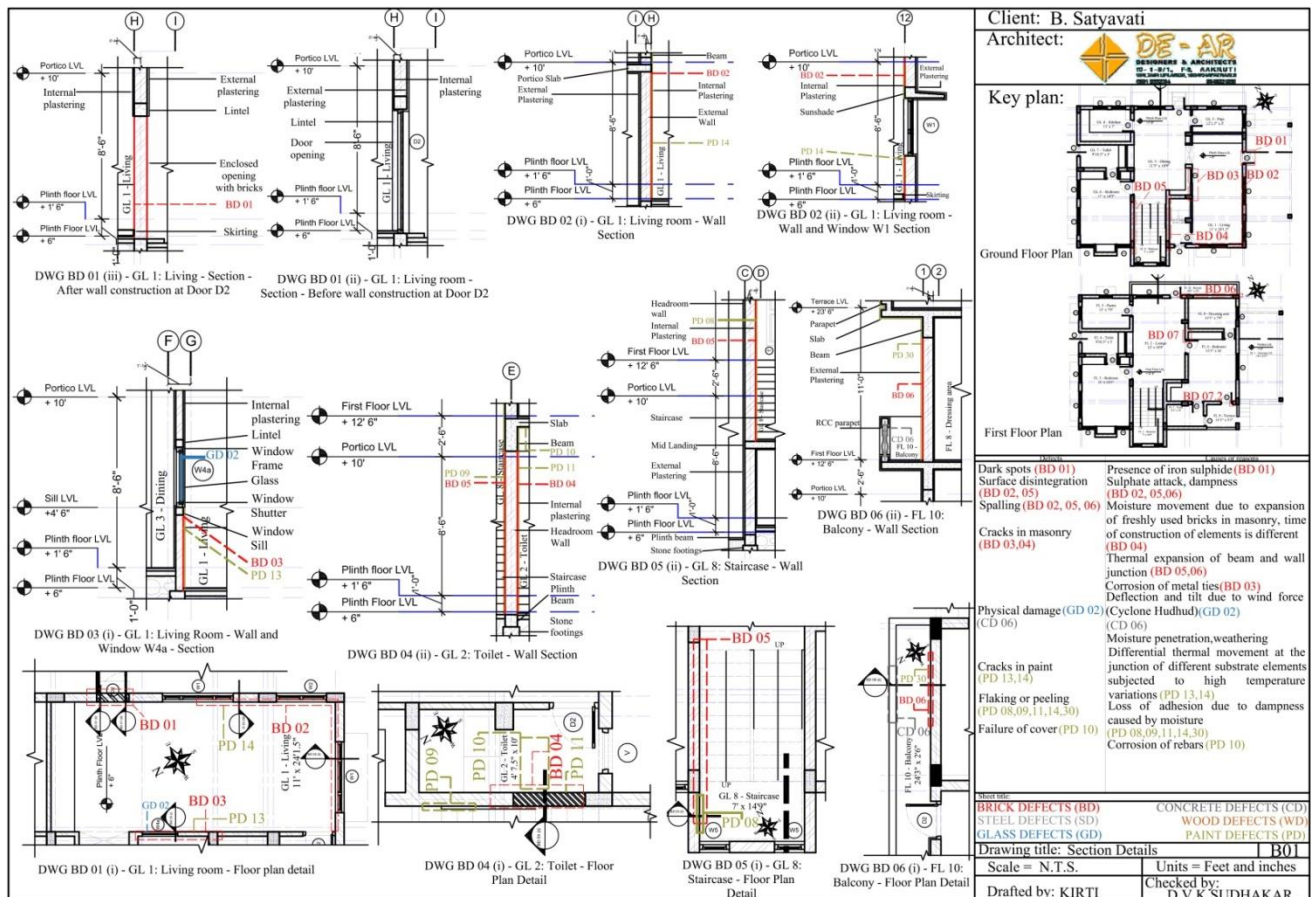
Figure 8 – Sheet B01: Architectural drawings of brick defects (BD) [4], [5], [10]

Patches or dark spots [5] on the surface of the brick [figure 6 (BD 01)] and cracks at the brick junctions due to the use of freshly used bricks in masonry that lead to expansion in response to the moisture movement [4].

Different time of construction of the wall [figure 9 (BD 04)] led to the difference in the coefficient of thermal expansion among its adjacent walls causing the development of cracks prone to the atmospheric agents.

Spalling and cracks in the brick wall [figure 9 (BD 02), figure 10 (BD 05), 11 (BD 06)] and the loss of paint coats.

Application of fresh coats at regular intervals on the brick wall surface is required for its protection which when avoided causes flaking or peeling of paint surface

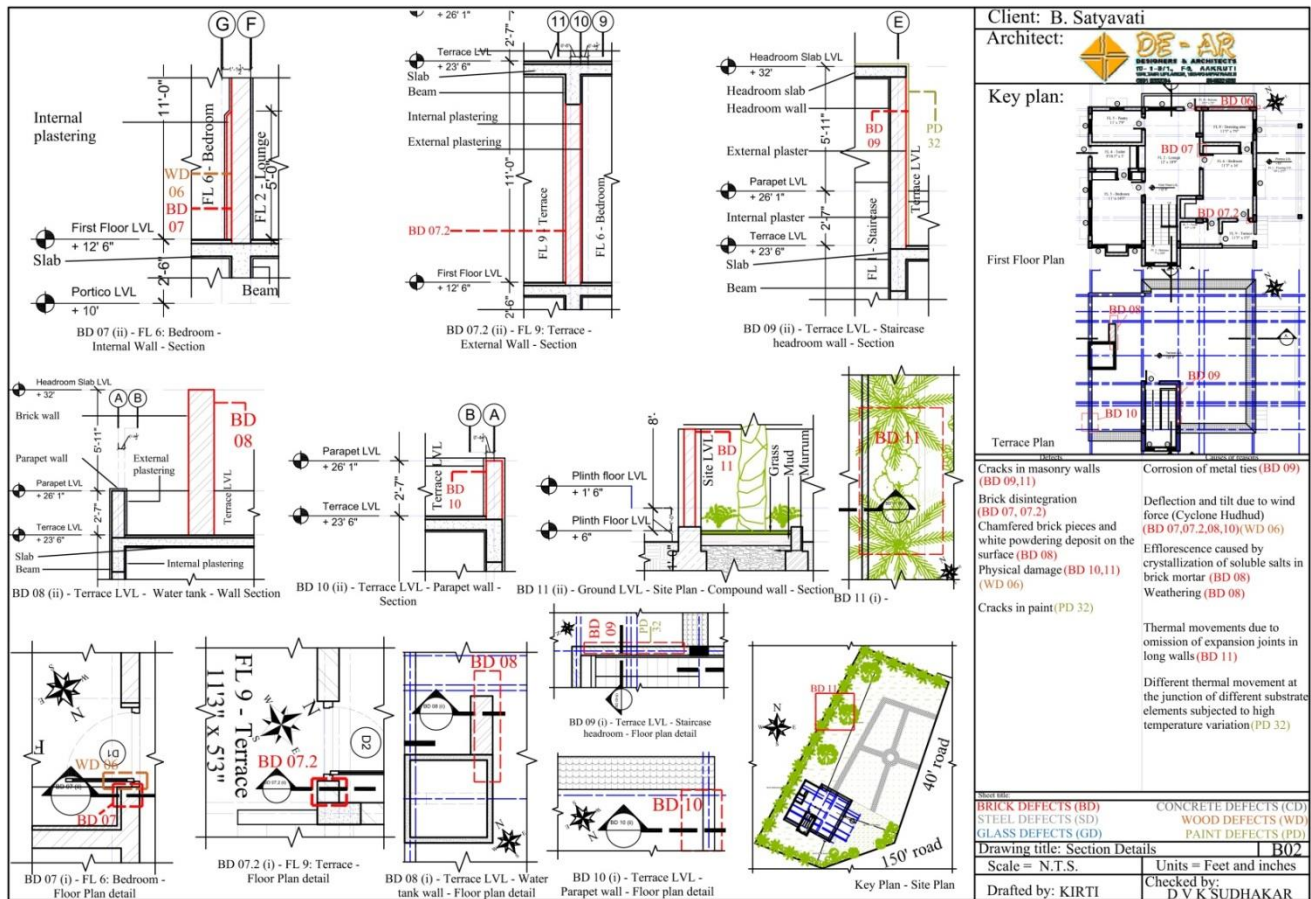
Figure 12 – Sheet B02: Architectural drawings of brick defects (BD) [4], [10]

Difference in their coefficient of expansion and contraction has led to the cracks at the junctions [figure 13 (b) (BD 03), 14 (BD 09)] resulting in the corrosion of metal ties which further expands the cracks.

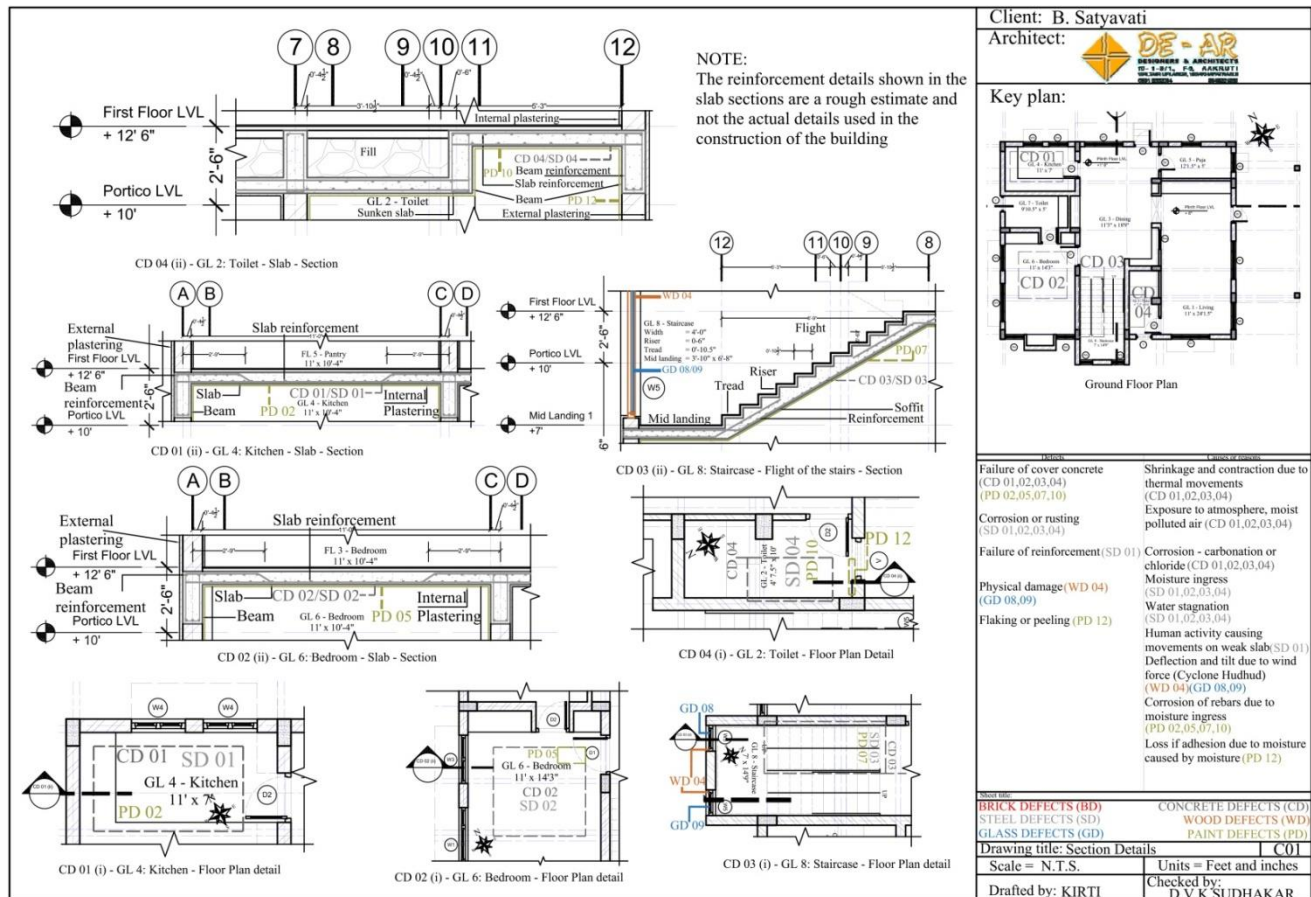
Figure 20 – Sheet C01: Architectural drawings of concrete defects (CD) [4], [10]

The defects in the components of a framed structure building would lead to the decrease in the stability resulting in its collapse after a brief period of time. Concrete slabs are the components that have been severely damaged.

The deterioration of the paint coats [figure 29 (b), 47, 49] and loss of concrete cover [figure 21 (b), 22 (b), 24 (b), 28 (b), 29 (b), 30 (c), 31, 32 (d)] are observed in most of the R.C.C components of the building.

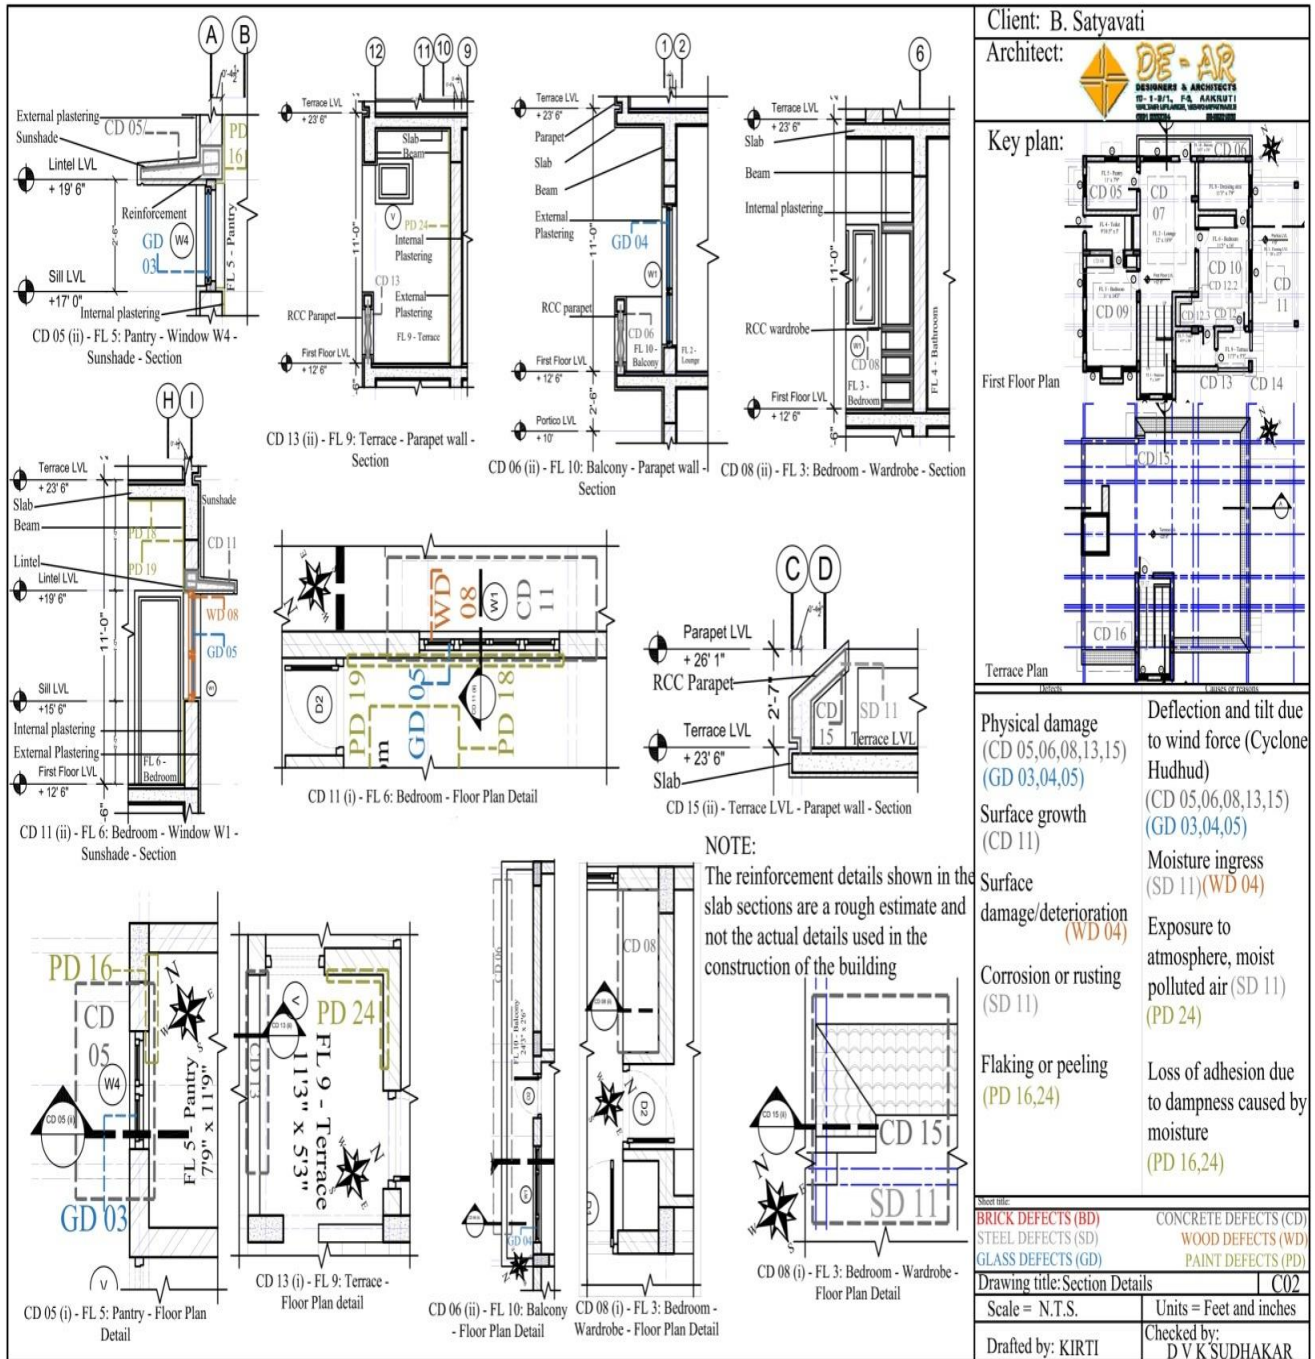
Figure 23 – Sheet C02: Architectural drawings of concrete defects (CD) [4], [5], [10]

There were no measures taken to ensure the draining away of the rain water that penetrated the building through the staircase headroom open roof [10] and remained stagnated [figure 28 (a), (c), 30 (d)] for a long period of time thereby reacting with the materials.

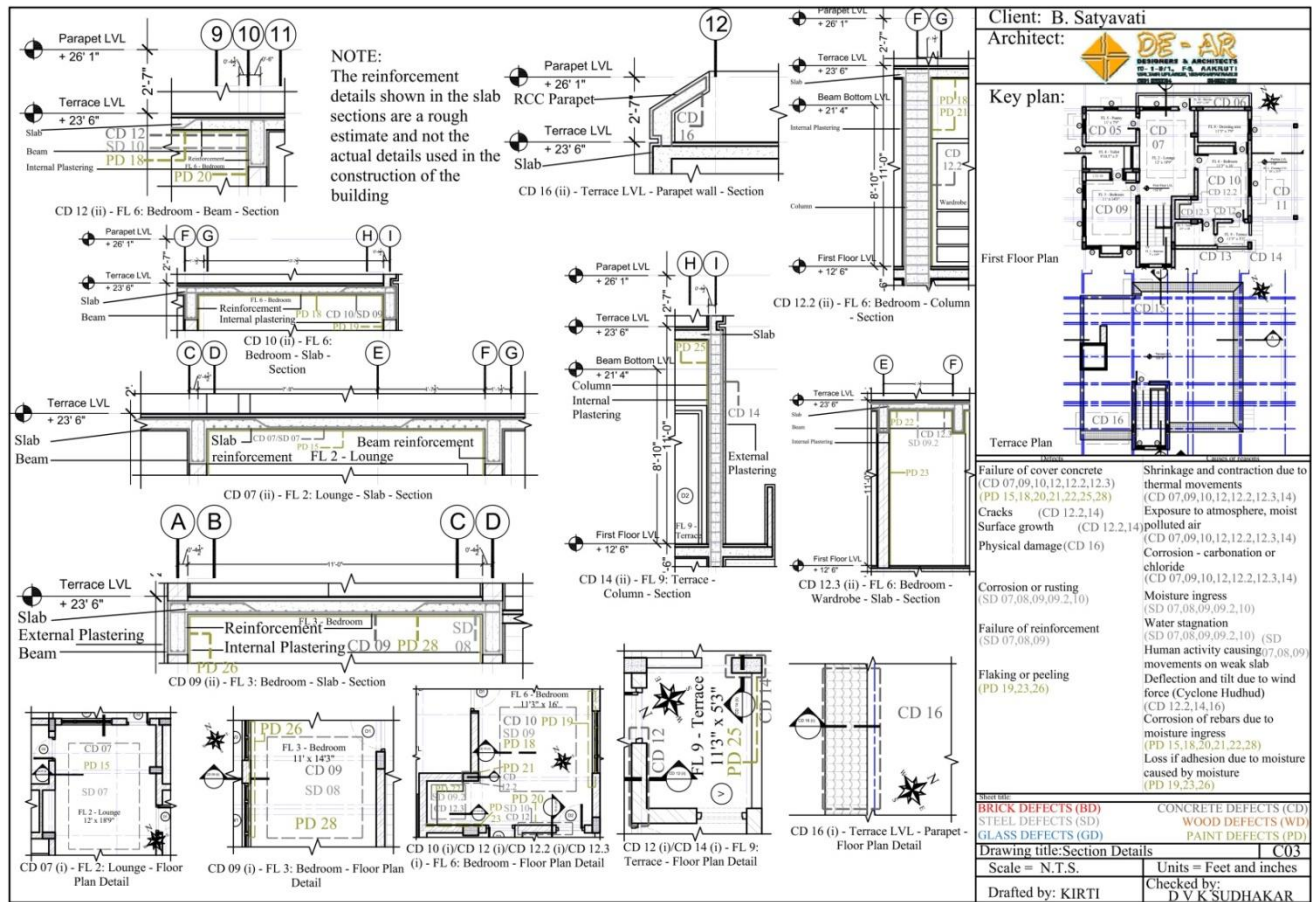
Figure 25 – Sheet C03: Architectural drawings of concrete defects (CD) [4], [10]

Broken sunshades, wardrobes, precast parapet structures, terrace parapet walls observed in the building [figure 34 (a), 35 (a), (b), 36, 38 (a)]

The stages of deterioration spans from weakening of materials, development of cracks, impact of wind force, complete or partial damage to the structure [figure 35 (b) (b1) to (b5)]

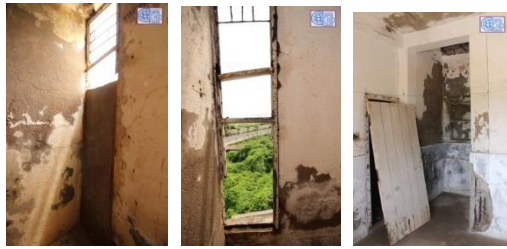
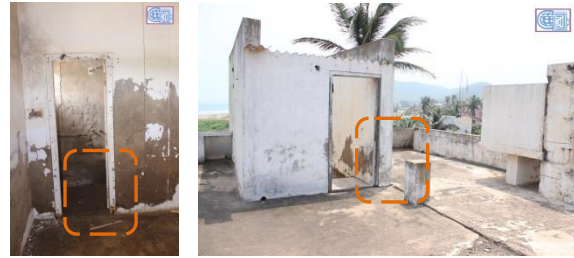
Figure 41 – (WD 03, 07, 09, 10) Wood defects (a) GL 8: Staircase – Window W5 – south east corner view (b) FL 1: Staircase – Window W5 – south view (c) FL 6: Bedroom – Door D2 – south west corner view (d) FL 6: Bedroom – north east corner view (e) FL 6: Bedroom – Door D2 - View (f) GL 1: Living – Door D2 – West view (g) Terrace level: Staircase headroom – Door D1 – South view

Distortion, surface damage [figure 36, 41 (d), (e)], rupture [figure 15, 16, 24 (c)], longitudinal cracks [figure 41 (a), (b), 50 (a), (b)] and cracking of glass panels [figure 41 (a), (b), 50 (a), (b)]

Wood has remained least affected among all the materials as the rate of degree of deterioration was very less. Only due to the physical damage [figure 41 (c)], the wood material became prone to remaining defects.

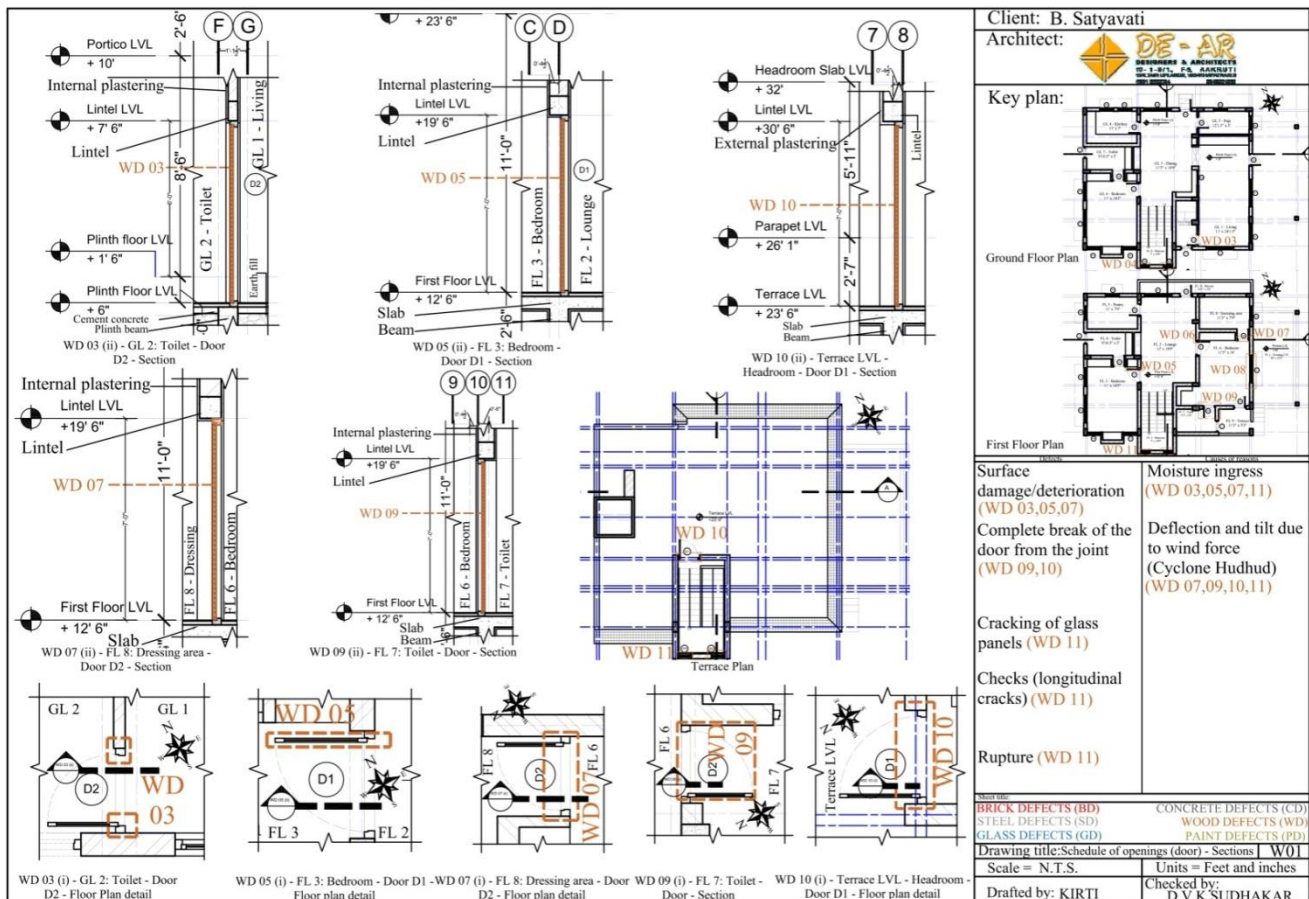
Figure 42 – Sheet W01: Architectural drawings of wood defects (WD) [4], [5], [10]

Wood is used for the frames and shutters of the doors and windows in the building. A total of 9 wood defects in number have been identified.

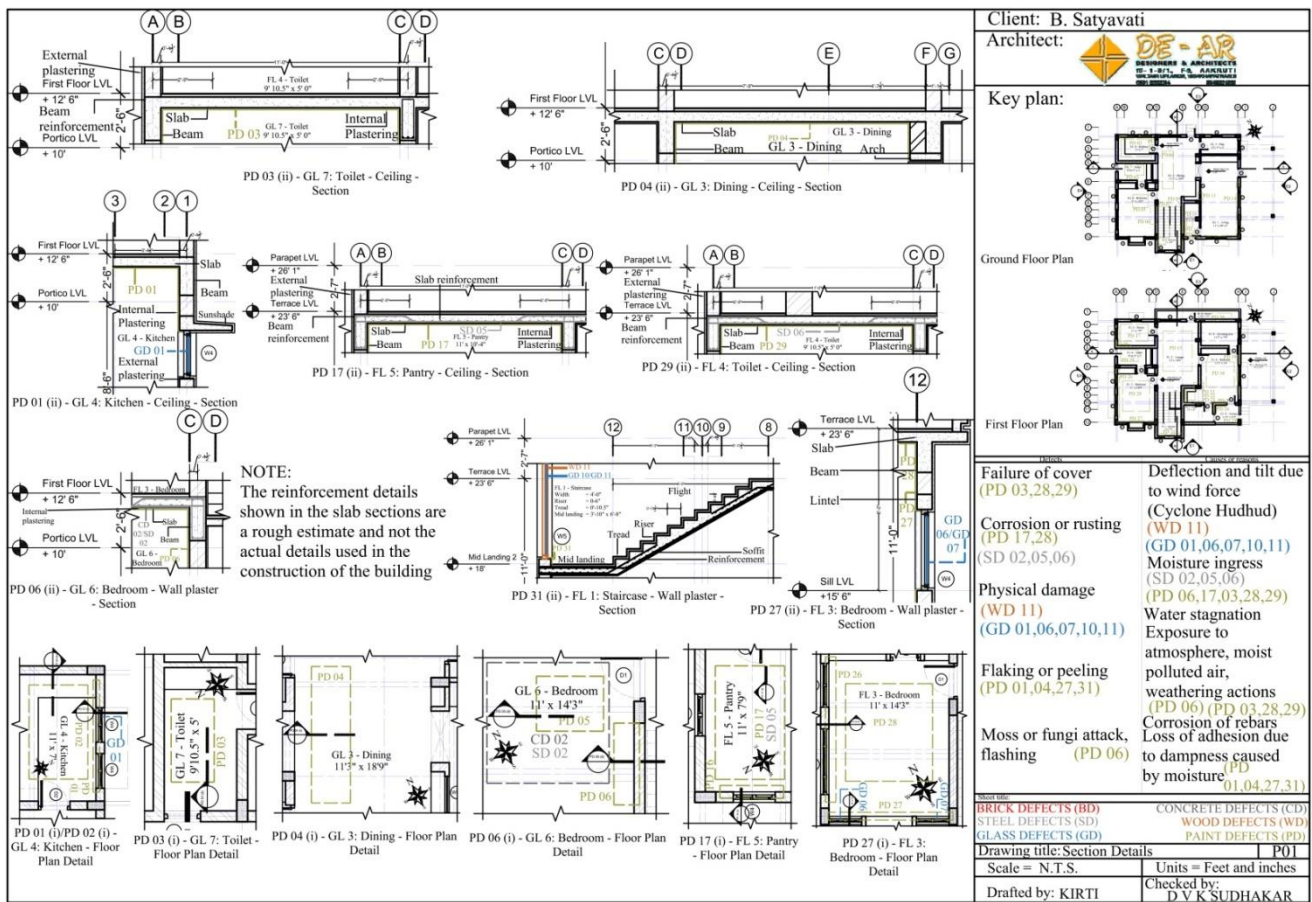
Figure 43 – Sheet P01: Architectural drawings of paint defects (PD) [4], [5], [10]

Loss of paint coats due to dampness, weathering actions, lack of regular maintenance, brown patches of red oxide on the surface due to corrosion of steel bars [figure 28 (b), 29 (b), 34 (b), 47, 49] and loss of coat cover due to corrosion [figure 51]

Re-plastering of the surfaces at regular intervals is to be done to ensure a good quality of paint against the climate. Alkali resistant paints should be used in coastal areas for better resistance against weathering [5]. Paint defects are observed within a short span of building functional life.
