# A CASE STUDY OF PRE-SERVICE CRACKS IN THE CONCRETE DECKS OF A TWO-LEVEL BASEMENT CAR PARK

This paper deals with the prevention of failure of structural elements made of reinforced concrete. It discusses pre-service cracks in the concrete decks of an underground parking facility. The cracks were assessed by analyzing their morphology. The results were used to determine the crack causes and the mechanisms of their initiation and growth. Some design solutions to prevent or reduce the occurrence of pre-service cracks are also presented.

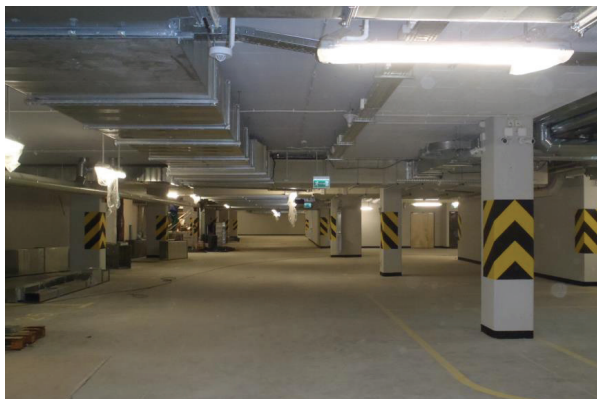
Fig. 1. View of level –1

The structure under study is a two-level basement (Fig. 1) extending beyond the superstructure walls, which is used for parking. Both slab decks were designed as non-beam decks with a thickness of 30 cm. They were constructed using C30/37 concrete and class A steel (grade RB 500W).

The deck viewed from level –1 is thicker between axes A and C; this is where the fire escape route runs. The floor finish and the structure of the deck depends on the function. The deck viewed from level –1

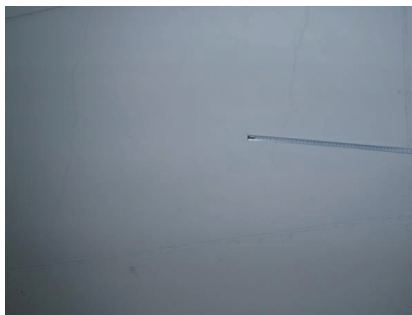
Fig. 5. Site 2: cracks in the deck underside viewed from level -2

Cracks were observed in the peripheral ties, i.e., ones adjacent to the slurry wall. The crack growth direction in the deck slab was also almost perpendicular to the slurry wall line. Like for level -1, the cracks generally had one end located in the area where the deck slab was in contact with the slurry wall (Fig. 5).

Also in the deck areas adjacent to two mutually perpendicular slurry wall sections, the cracks were almost perpendicular to the angle bisector formed by the parting line between the slurry wall sections.

The inspection did not confirm that the cracks propagated across the whole thickness of the slab because it was an interfloor slab and no access was available to the top because of the flooring.

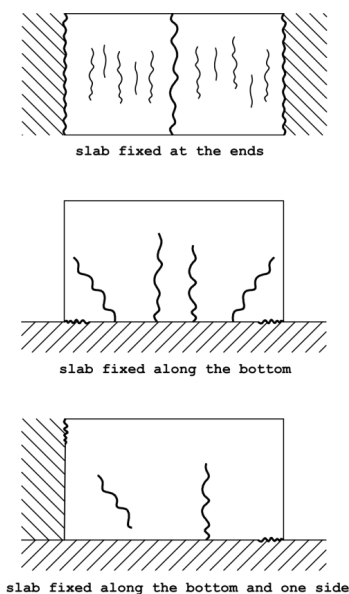
Fig. 6. Deformations imposed by fixed external restraints

In reinforced concrete buildings with cast-in-place structural elements, deformations may occur due to fixed external restraints. Some basic examples are shown in Fig. 6.

The phenomena that may be responsible for the occurrence of this type of deformations include:

- concrete shrinkage,
- a fall in temperature.

However, the factors affecting the cracking differ in the two cases. In practice, forced deformations are observed after:

- placing concrete in between two existing sections,
- placing concrete to extend the existing section on either of the restrained edges.

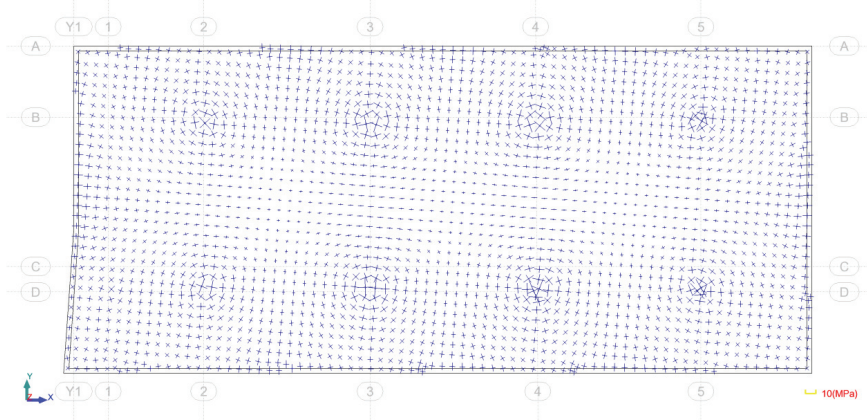
Fig. 7. Directions of the primary stress

In this study it was assumed that internal forces caused by gravity loading were not responsible for the cracking. It should be noted that the location and layout of cracks in the deck under excessive gravity loading are completely different. Examples of calculation results are shown in Figs. 7 and 8.

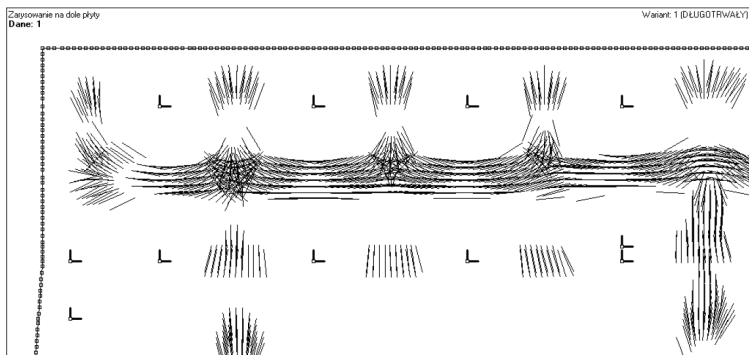
Fig. 8. Map of cracking on the slab underside [5]

The flatness of the underside of the decks was assessed by measuring the distance to the floor with a laser tape measure and a leveling instrument. The vertically measured ordinates allowed us to draw a map of cracks present on the underside of the decks viewed from levels  $-2$  and  $-1$ . The measurement profiles in selected areas were almost linear in nature.

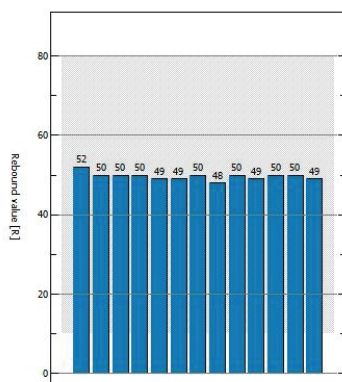
Fig. 9. Results of the Schmidt hammer tests for one of the measurement points

It was assumed that no significant tensile forces would occur in the deck slabs under service conditions. Another assumption was that the forces due to concrete shrinkage had decreased sufficiently. It was thus concluded that the process of split cracking was practically over and the cracks were stable. An ND type Schmidt hammer was used to determine the strength of the concrete. The non-destructive testing inspection was performed according to the relevant standard and the manual by the Institute of Construction Engineering. The concrete strength was determined from the rebound readings obtained for six randomly selected points. On the inspection day, the characteristic cylinder strength of the concrete slab ( $f_{ck}$ ) viewed from level -2 was approximately 60 MPa, while that viewed from level -1 was about 50 MPa. Examples of the measurement results are provided in Fig. 9.

Number of measurements N = 13  
 Mean rebound value m = 49.7 R  
 Mean compressive strength f<sub>ck</sub> = 60.2 MPa  
 Standard deviation sa = 0.9 R  
 Maximum rebound value Max = 52 R  
 Minimum rebound value Min = 48 R  
 Span R = 4 R

The non-destructive tests showed that the designed strength class of concrete had already been achieved. Standard calculations confirmed that the building was safe to use and the load-carrying capacity of the decks would be sufficient under service conditions. The effect of a considerable drop in the deck temperature was not analysed.

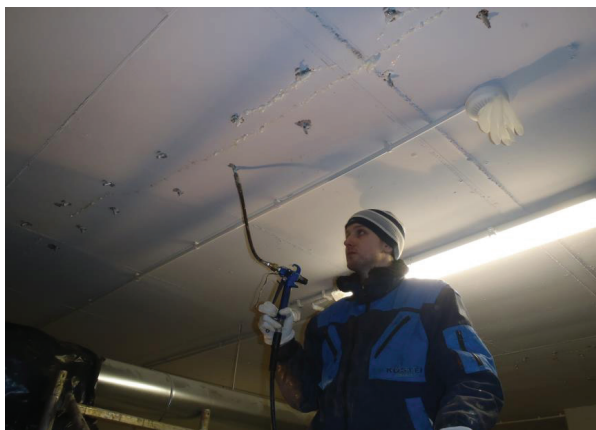
Fig. 10. Crack sealing at site 8

The structure of the deck and the minimum cross-sectional area of reinforcement contributed to the relatively uniform distribution of cracks caused by forced deformations and their limited width. If the width of a crack does not exceed 0.2 mm, the crack is actually acceptable by standard for the XD1 exposure class. It was assumed that the seepage would probably stop with time because of the formation of self-sealing CaCO<sub>3</sub>. The deckviewed from level –1 required immediate sealing by injection (Fig. 10), which is a standard procedure.

Elastic polyurethane resin was used for this purpose. It was also recommended that the behaviour of both decks be monitored in the initial period of operation of the building in order to empirically confirm the stability of the existing cracks.
